AN EXPERIMENTAL
STEEL — FIBER — REINFORCED CONCRETE
BRIDGE DECK OVERLAY

AN EXPERIMENTAL STEEL-FIBER-REINFORCED CONCRETE BRIDGE DECK OVERLAY

Technical Report 18
April 1975

Bridge No. 2
Over the Roeliff Jansen Kill
Rhinebeck-Hudson, Part 4
N.Y.S. Route 9G, S.H. #8359
Columbia County
Contract No. RCR 73-85
Project Identification No. 8001.12

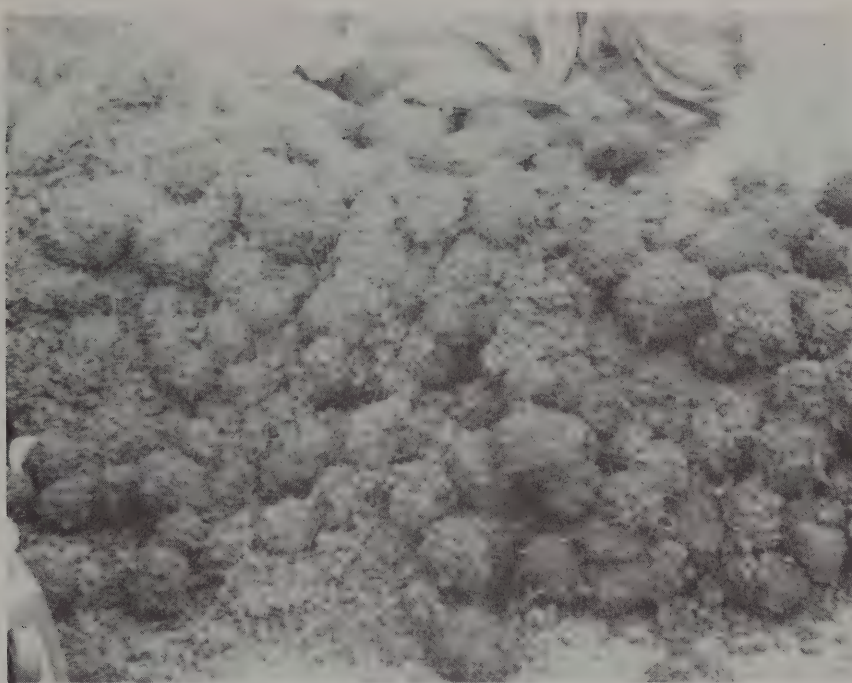
Figure 5. Balls of fibers removed from the deck.

The northbound lane was allowed to cure for the specified 15-day minimum before opening it to traffic, which was then wholly diverted to this lane as preparations began for paving the southbound lane. The entire southbound lane was overlaid on November 15, 1973, and some difficulties were encountered. This lane was to receive the mix recommended by Battelle on October 1. The first truckload of fibrous concrete, which arrived on the job at 8:25 a.m., was a wet load containing many fiber balls. It was rejected. The second truck arrived at 8:50; it too contained balls, but since slump and air were within specification limits, this load was used. The contractor was instructed to remove all balls from the deck. Two wheelbarrow loads were removed, probably representing 200 to 300 lb of fiber, or 1/3 to 1/2 the fibers in the truckload. The third, fourth, and fifth trucks to arrive on the job also contained balls. In addition to balling, the third truck had a wet load and was rejected. The fourth and fifth truckloads were used with the fiber balls removed. Figure 5 shows balls of fibers removed from the deck.
